STABILISATION OF AN EXISTING RAILWAY EMBANKMENT USING SMALL DIAMETER MINIPILES AND LARGE DIAMETER PIN PILES AT KITSON WOOD, TODMORDEN

J Martin
Technical Manager (Ground Engineering)
Kvaerner Cementation Foundations
Bentley Works, Doncaster
South Yorkshire DN5 9RX

KEYWORDS: Embankment Stabilisation, Pin Piles, Minipiles, Horizontal Ties, Long Term Monitoring.

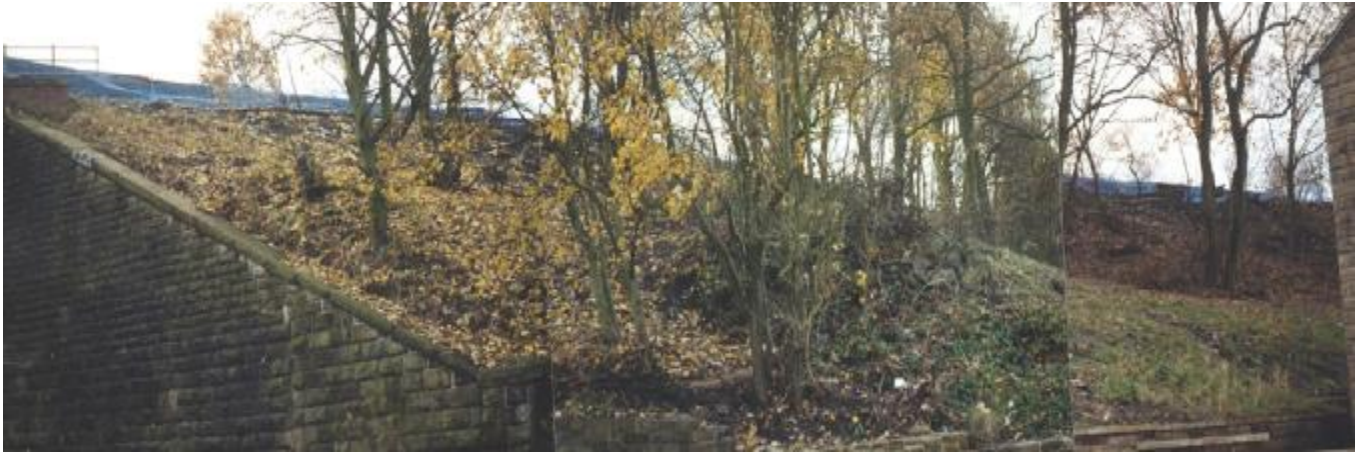
Figure (i) - Original Embankment Prior To Any Remedial Works (Late 1997)

This £850,000 design and build contract involved the stabilisation of approximately 80 m of embankment adjacent to Underbridge No. 5 at Kitson Wood in Todmorden (see fig [i]). The works were undertaken by Kvaerner Construction (KC) and Kvaerner Cementation Foundations (KCF), operating under a partnership agreement for Railtrack Project Delivery (North West). Underbridge No. 5 is at 29miles 58 chains on the Burnley Branch Line between Hall Royd Junction and Gannow Junction. The line is not electrified and has two tracks which are used for both freight and passenger services.

Inclinometer and reference peg readings taken during 1997 indicated surface movements of up to 150mm over a 6 month period. A combination of deep seated rotational movement and ash/ballast ravelling over and down the steep embankment shoulders as the trains passed were deemed to be the most probable failure mechanisms. This significant movement resulted in a monthly re-ballasting requirement of approximately 40 tonnes to keep the railway lines within the required tolerances. Furthermore, a 5 mph TSR was imposed to minimise dynamic loading and consequent settlement. The combination of re-ballasting (which only exaggerated the movement by applying additional surcharge) and TSR were creating serious commercial and safety issues within Railtrack and a permanent long term solution had to be sought.

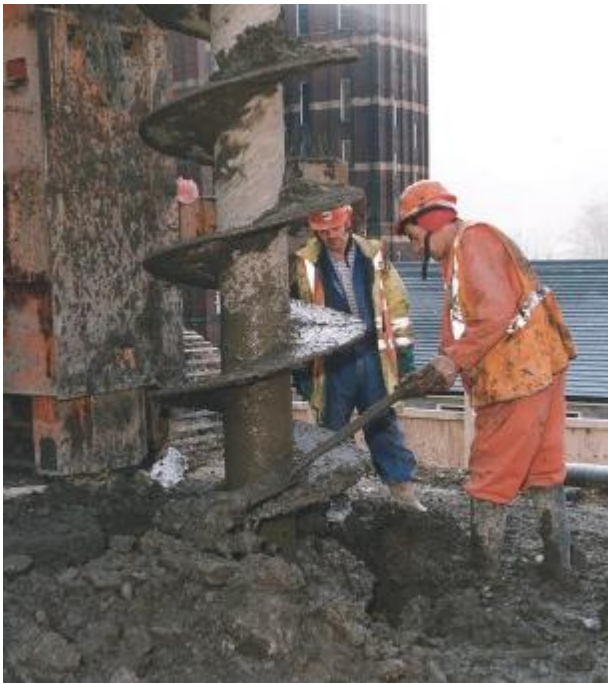
The 900mm diameter x 15 metre deep CFA piles were constructed using a Soilmec R622 piling rig. This is one of Cementation's largest rigs weighing 70 tonnes and is capable of generating 220 kNm of torque. The 900mm diameter continuous auger string was bored to 15m depth and then concreted through the hollow stem as the auger was extracted. A total volume of approximately 10m³ to 12m³ of concrete was required for each pile. The whole process was carefully monitored via pressure and flow measurements to ensure a homogenous 900mm diameter pile was formed over the whole length (see figures [v] and [vi]). A C35 blended concrete pump mix was delivered to site in 6m³ wagons and temporarily stored in an agitator for onward distribution to the pile bore as required. The CFA piling technique proved eminently suitable for these ground conditions and the piles were formed in an efficient manner with minimal vibration and relatively little noise.

Figure (v) - Construction of 900 mm Diameter CFA piles

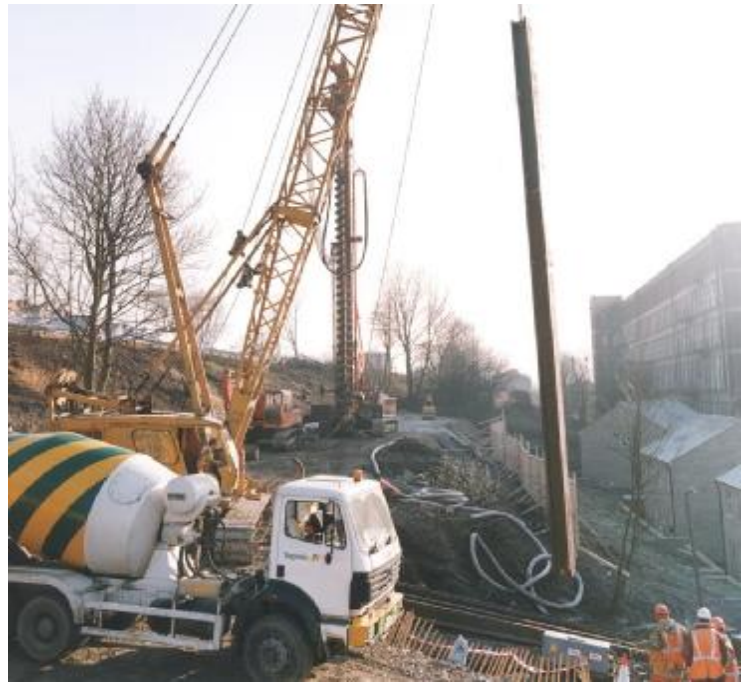
Figure (vi) - Lifting of Universal Column (note the steepness of the overall slope)

Immediately following completion of the concreting of the bore the heavy section UC was carefully lowered in to the full depth, ensuring that the correct orientation was maintained. Each 15m long UC weighed 8.3 tonnes and was formed by welding together a 10 metre and a 5 metre section. A 45° point was formed at the bottom end and a lifting eye at the top. All of the fabrication works were carried out at Cementation's plant and workshops depot in Bentley near Doncaster, using coded welders. Centralisers were added to the UC at regular intervals during installation. All of the concreted bores were formed and UCs inserted to the full depth without any problems and production rates of 6 to 8 piles per day were achieved (see figures [vii] and [viii]).

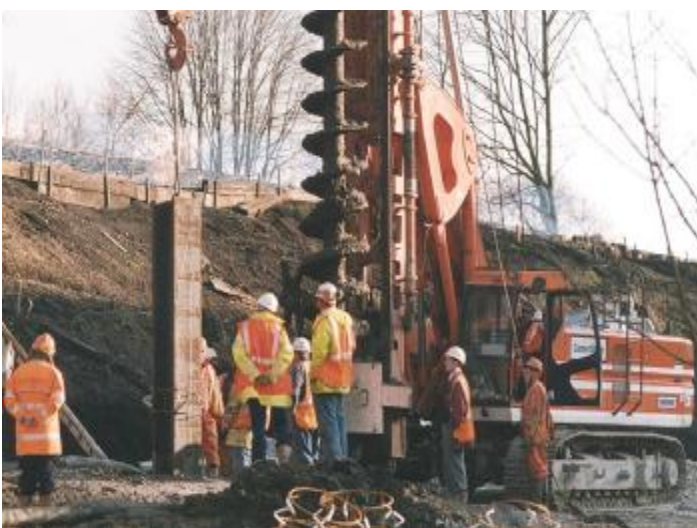
Figure (vii) - Installation of Universal Column

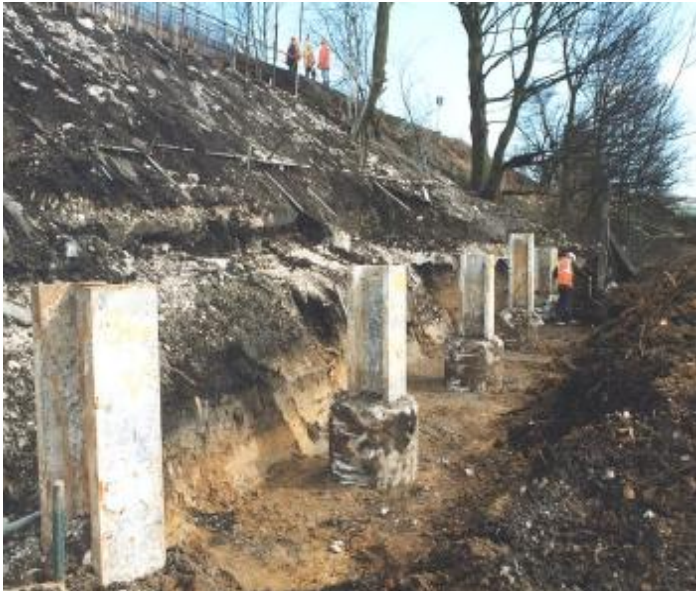
Following completion of pin pile installation, a 2.0m high reinforced concrete wall/capping beam was constructed which connected together the front row of pin piles (see figures [ix] and [x]). The main

Figure(ix) - Trimmed Pin Piles

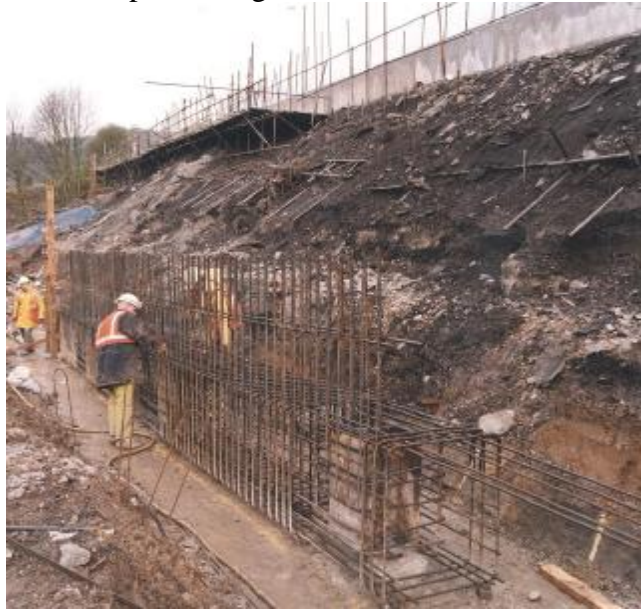
Figure(x) - Retaining Wall Reinforcement

reasons for this wall were to reduce the slope over the top critical section of the embankment and also to provide relatively level rear gardens to the new properties. Communication and liaison between Railtrack and the local residents was extremely important and they were kept fully informed of all proposals and developments. Inevitable disruption and inconvenience was caused during the works, especially during the closure of the adjacent Ashenhurst Road for approximately 4 months. The overall scheme for the garden re-grading/retaining wall/landscaping was jointly discussed, developed and agreed with the local residents.

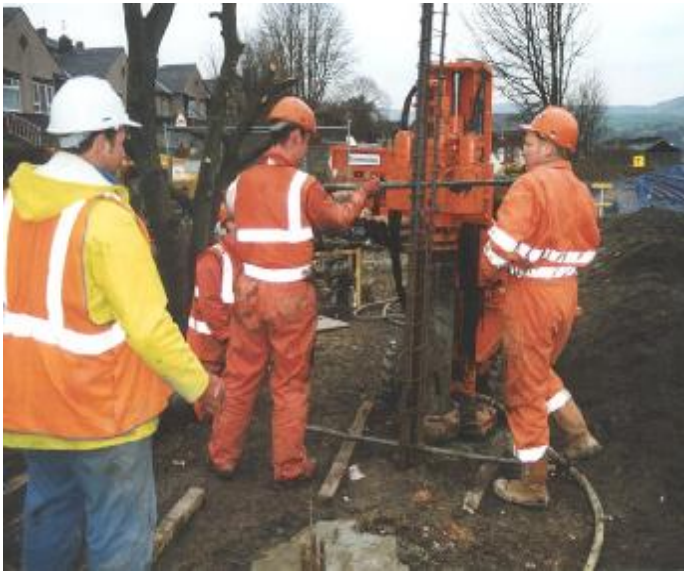
The minipiles were installed using two twin tech TD308 drill rigs with 2.2m masts. These are the smallest rigs in Cementation's fleet and consist of a 1.5 tonne drill unit and a 1.5 tonne powerpack, which may be up to 30 metres away. Most of the drilling was undertaken from scaffold platforms along either side of the embankment. Prior to commencement of any operations, a green zone fence line was erected 3.0m from the nearest running rail to allow the works to take place whilst the line was in operation. The fence lines and scaffold platforms were vitally important with regard to safety and great care was taken with their construction. In particular, the transom spacing was matched with the minipile spacing to ensure ease of installation. Temporary 273mm OD diameter casing was used through unstable strata and 240 mm diameter open hold boring thereafter. A specially purchased boring head was used to penetrate the mudstone bedrock using augering techniques. Following drilling to the required depth, the augers were carefully removed and a 1:1 colloiddally mixed sand:cement grout with a 0.42 water:cement ratio was pumped into the base until full. The centralised reinforcement cage was then immediately installed to the full depth. Production rates of between 5 and 8 minipiles per day per rig were achieved (see figures [xii] and [xiii]). These minipiles were installed to within 1.0m of the rear of the bridge abutments.

Figure (xii) - Installing Minipile Reinforcement

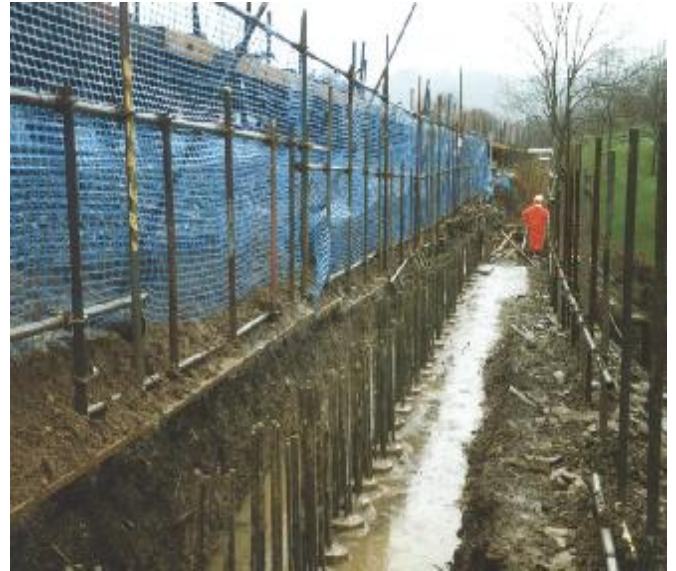
Figure (xiii) - Trimmed Minipiles

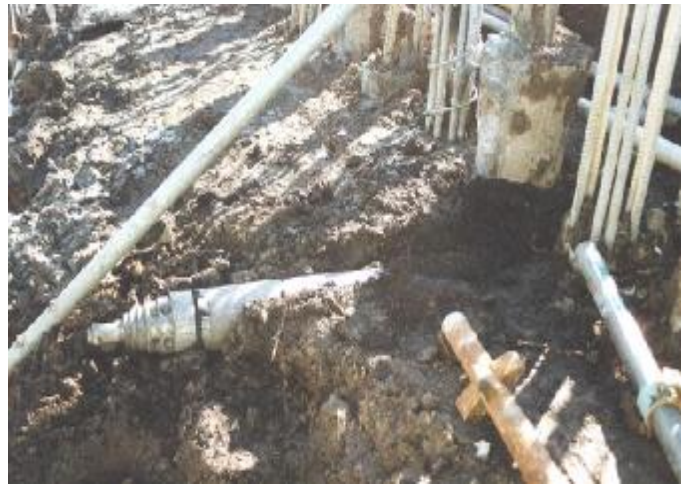
Upon completion of the minipiles, the installation of the ties commenced. These were installed using a small 'Grundomat' pneumatic hammer.

Minor problems were encountered during the installation of the initial ties due to the grundomat hammer meeting obstructions. The most suitable ground conditions for the grundomat hammer would be a firm consistent cohesive fill/natural material. The solution was to resource a hammer which was able to install its own plastic liner as it drilled, and then retract back along it if an obstruction was encountered. Upon reaching the far side the hammer was removed leaving the plastic liner insitu through the embankment into which the 50mm diameter rebar could be installed in 4 metre sections, connected together using full strength couplers. Alignment was generally good when the grundomat had been set up/off correctly

Figure (xiv) - Grundomat Hammer

and no major obstructions were encountered, on average an installation tolerance of 1 in 50 was achieved. Production rates of 3 ties / day were achieved after the initial problems (see figures [xiv], [xv] and [xvi]).

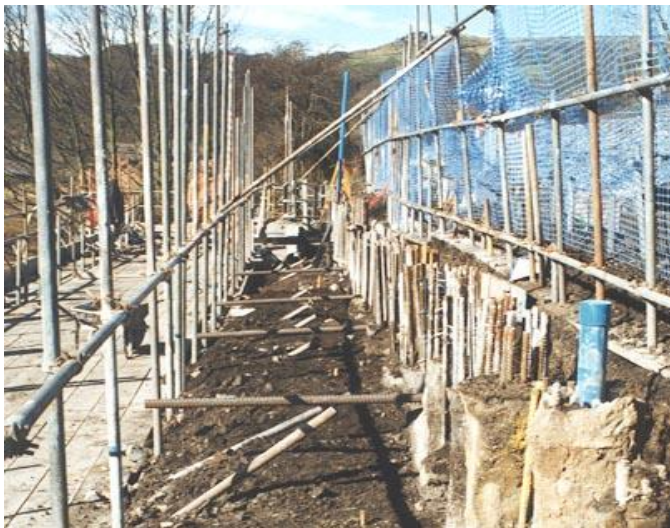
Figure (xv) - Tie Installation Complete

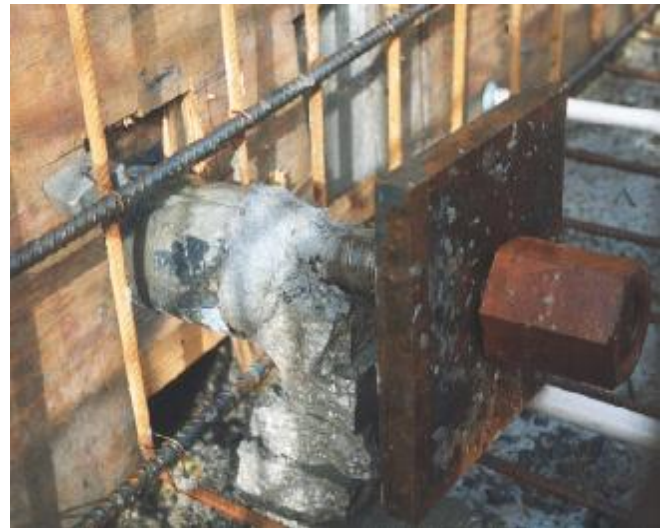
250mm square x 30mm thick mild steel plates were proposed for each end of the tie.

Figure (xvi) - Tie Bearing Plate

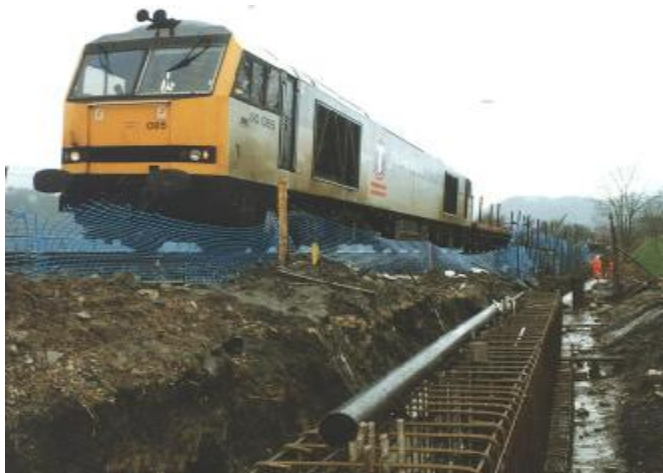
Finally, the r/c beam with tie plates, drainage and compacted free draining shoulder support were completed by Kvaerner Construction with the line open throughout (see figures [xvii] and [xviii]).

Figure (xvii) - Beam Reinforcement

A 1.4m deep x 0.7m wide r/c "capping" beam was used with nominal reinforcement to connect the ties to the minipile walls. The design and construction of this beam followed the guidelines of BS 8110 and is not covered within this paper.

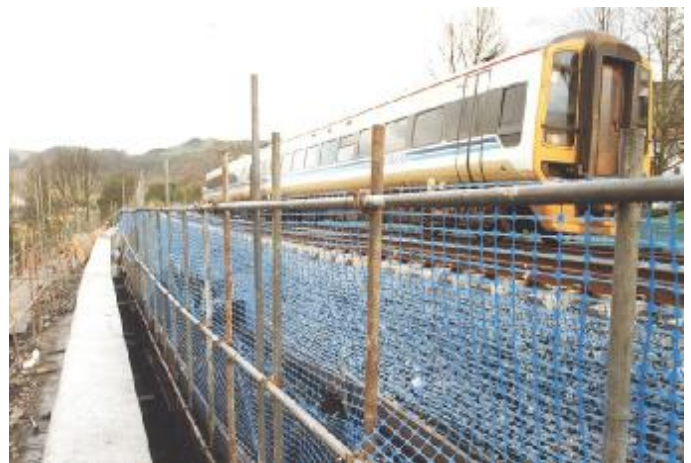
Figure (xviii) - Completed R/C Beam

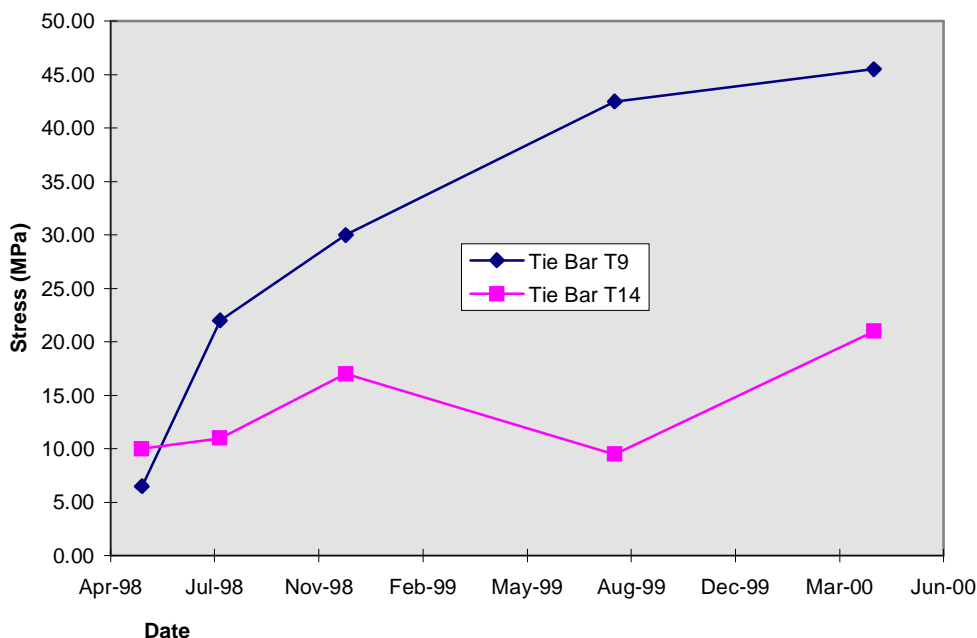
Figure (xix) Average Tie Bar Stresses

The average tie bar stresses are given in figure (xix) to date which shows the maximum stress to be levelling off at around 50 MPa in T9.

A stress of 50 MPa in Tie T9 is equivalent to a force of 98.1 kN, which is 29% of the design force of 336.0 kN.

Tie bars T9 and T14 passing through the railway embankment have been instrumented with vibrating wire strain gauges. Each tie bar has been fitted with two pairs of gauges, one pair at each end, approximately two metres from the r/c capping beam.

Tie bar T9 is in the middle of the problematical section of embankment where the

movements have been the greatest. Tie bar T14 appears to have a stress level of around 50% of T9. This may be due to the proximity of the bridge abutment which is approximately 10m away providing additional support.

The generated force of 98.1 kN in T9 would cause an extension of approximately 4mm which is reasonable when compared with the inclinometer readings.

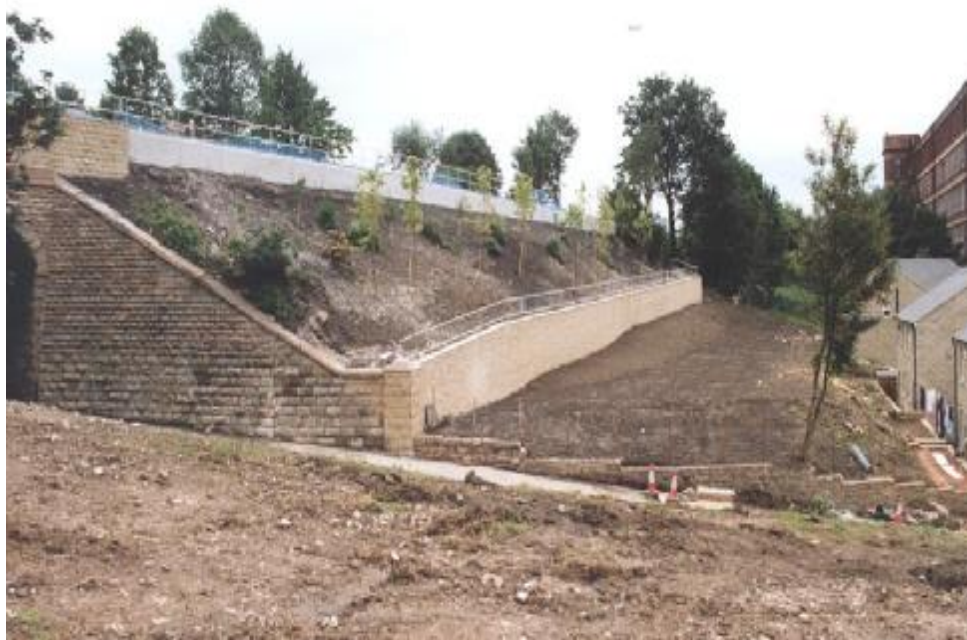
Figure (xx) - Completed Remedial Works
